**LARGE AREA COMPOSITE INSPECTION  
SYSTEM LACIS-D**

**FINAL REPORT FOR PERIOD SEPTEMBER 1993 to AUGUST 1995**

| REPORT DOCUMENTATION PAGE | | | FORM APPROVED<br>OMB NO. 0704-0188 | |
|---|--|---|---|--|
| 13. ABSTRACT (Maximum 200 words)<br>The purpose of this program was to conduct the advanced development, integration, modification, and demonstration of a large area nondestructive inspection technique for the rapid detection and quantification of material properties and defects in large fiber-reinforced composite aircraft compoents. | | | | |

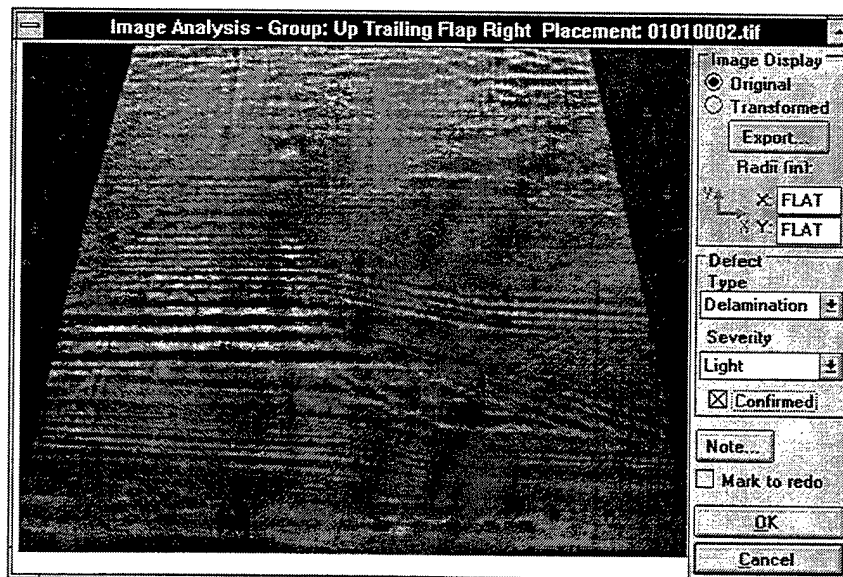
**Figure 40: Analysis Dialog Box for Viewing and Marking Defects**

The critical display of the image is provided in a dialog box shown in 73. If the image in the placement box indicates corrosion and is marked accordingly, the placement box is marked in red on the turtle diagram on exit with an OK. The aircraft work file is then updated with the defect type and severity. If no corrosion is found, the placement box is marked with green on exit with an OK.
